REPORT OF MECHANICAL TEST

SAMPLE ID: 1 each: 95WM (Copper S Horn) 2 O-Ring
 95WM (Copper S Horn) 3 O-Ring

SUBJECT: Hydrostatic Pressure Test

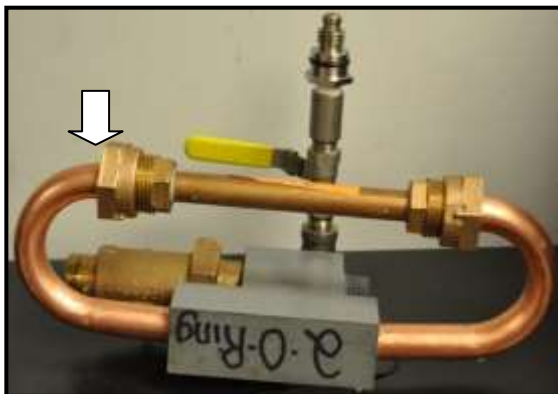
Sample	Pressure (Psig)	Result
95WM (Copper S Horn) 2 O-Ring	120	Slow Leak (See Picture)
95WM (Copper S Horn) 3 O-Ring	350	Spray (See Picture)
