#66WC-D SAMPLING STATION

SHEET 1 OF 1

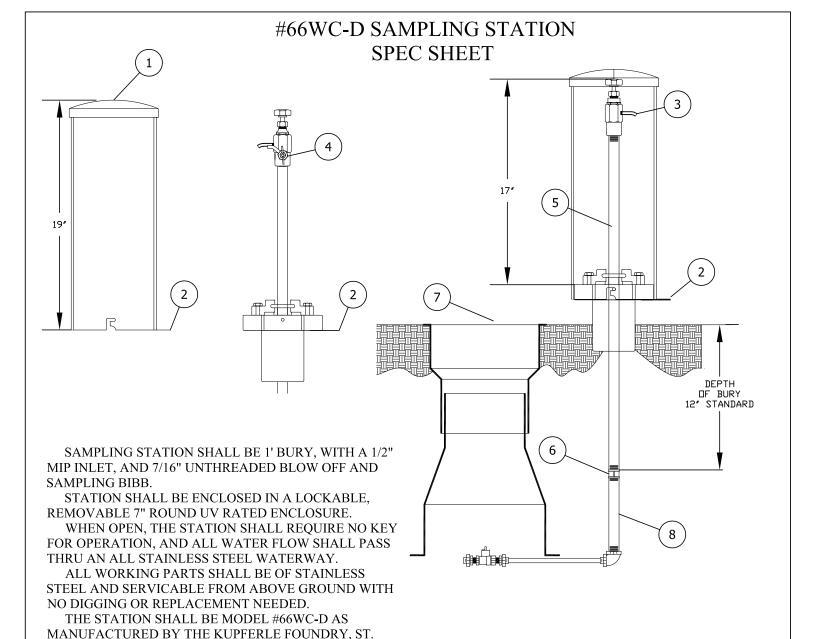
IN SOME CONDITIONS CORROSION OF STAINLESS STEEL CAN OCCUR (EXPOSURE TO SALT WATER, DIRECT EXPOSURE TO STRONG CHLORIDES, ETC.). PROPER MAINTENANCE OF THE EXPOSED STAINLESS STEEL PARTS USING PROPER STAINLESS STEEL CLEANING AGENTS WILL INCREASE THE LIFESPAN OF THE HYDRANT. IF DESIRED, KUPFERLE CAN ALSO OFFER AN ADDITIONAL PASSIVATION PROCESS FOR ADDITIONAL CORROSION PROTECTION.

ITEM	ITEM / DESCRIPTION	NOTES
1	7" ROUND UV RESISTANT ENCLOSURE	
2	LOCKING BRACKET	
3	BLOW OFF	
4	PET COCK SAMPLING BIBB	
5	1/2" S.S. WATERWAY	
6	1/2" S.S. COUPLING	BY OTHERS
7	VALVE BOX	BY OTHERS
8	1/2" S.S. NIPPLE	BY OTHERS
